# VEHICLE INSPECTION REPORT

**SG13WHA**

## Peugeot Bipper 1.3 HDi 75PS

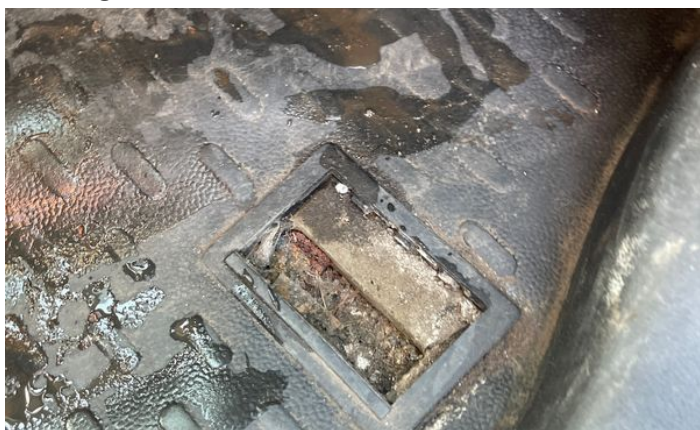
1: Carpets Front  
Missing  
Replace

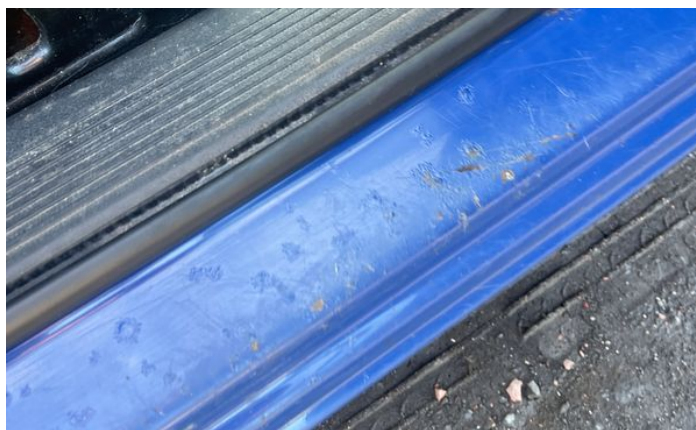
2: Sill os  
Rusted  
Over 5mm

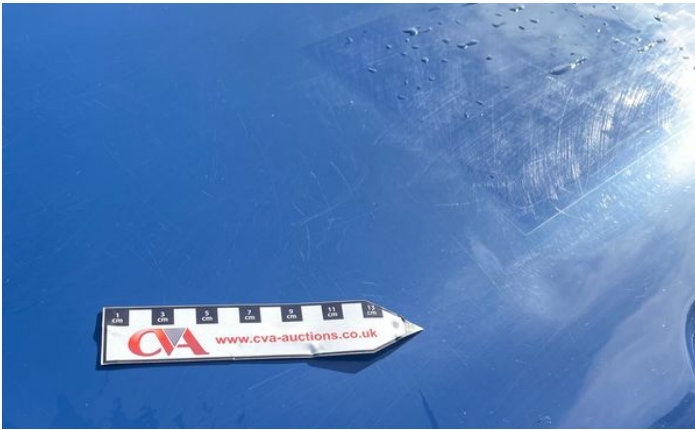
3: Bonnet  
Dented  
Over 30mm

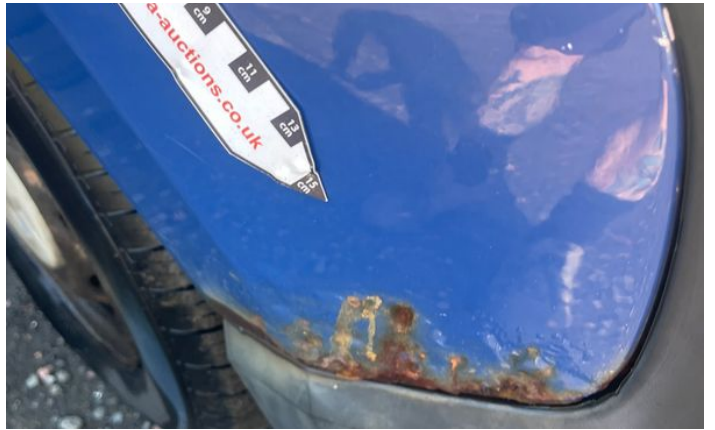
4: Wing osf  
Rusted  
Over 5mm

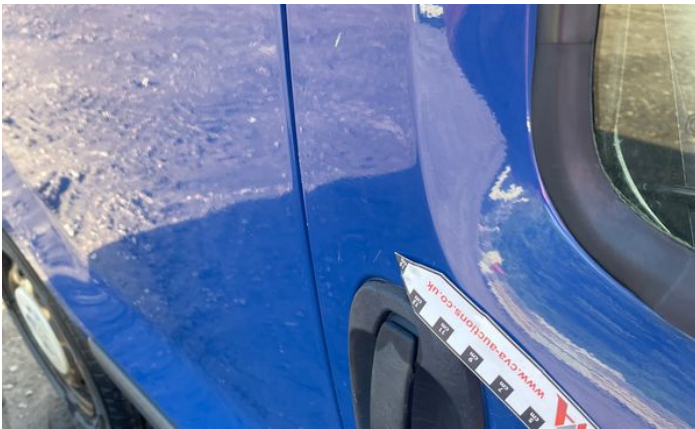
5: Door osf  
Dented  
With Paint Damage

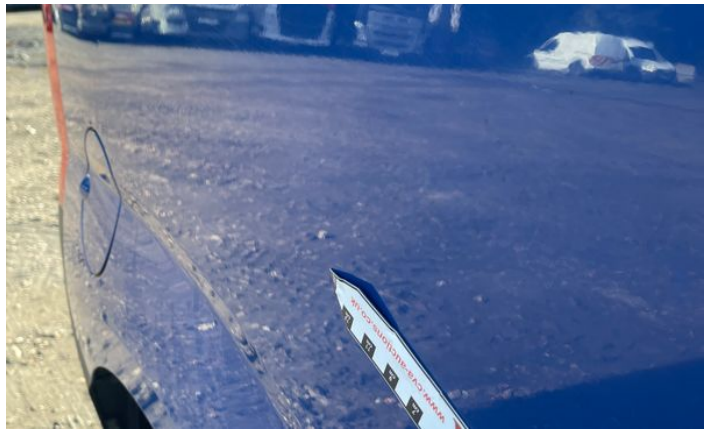
6: Qtr Panel osr  
Dented  
Over 2 UpTo 10mm

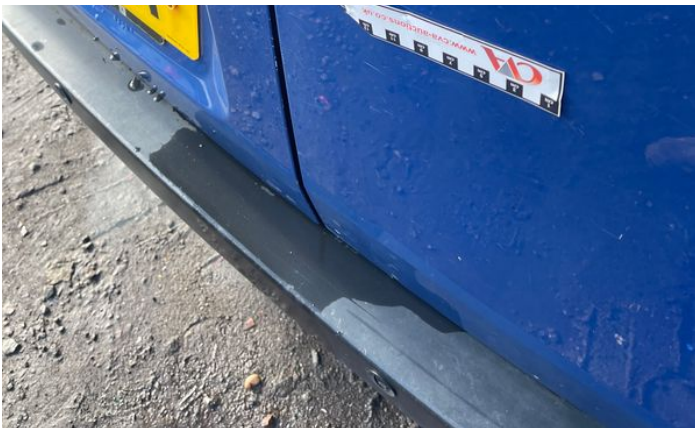
7: Tailgate  
Dented  
Over 30mm

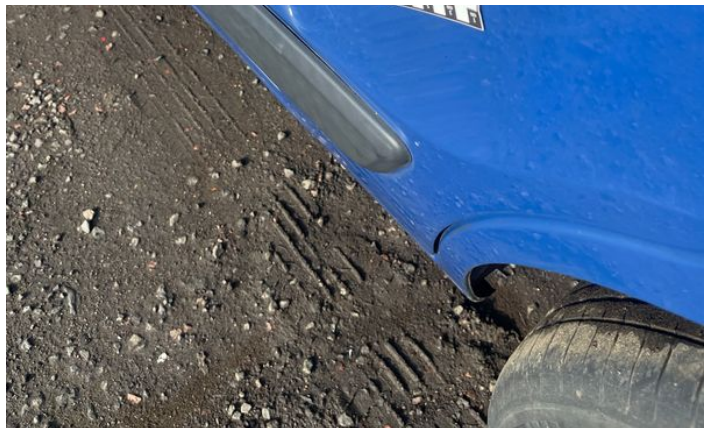
8: Door nsr  
Dented  
With Paint Damage

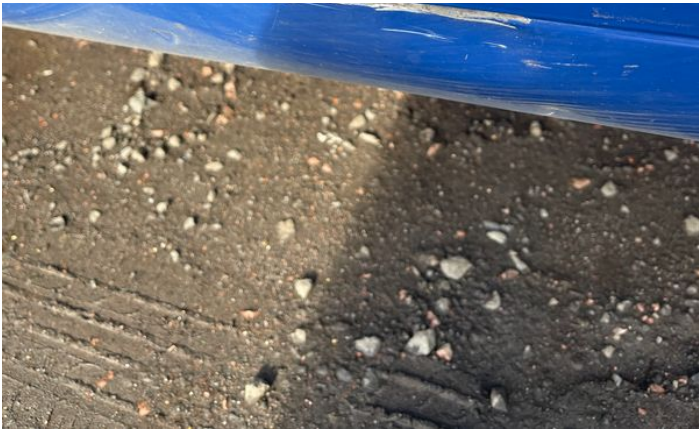
9: Sill ns  
Dented  
With Paint Damage

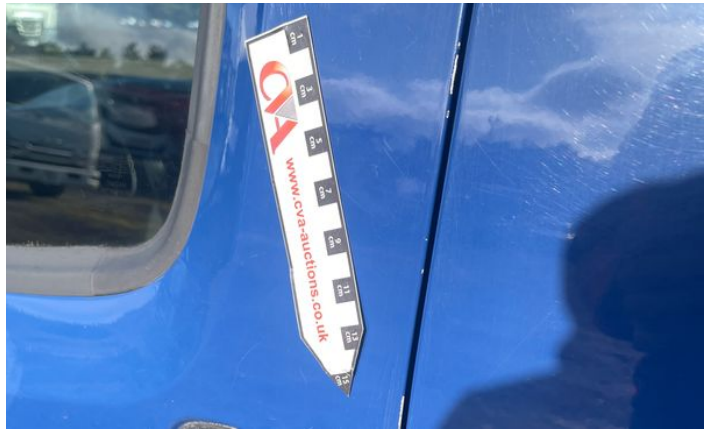
10: Door nsf  
Dented  
Over 30mm

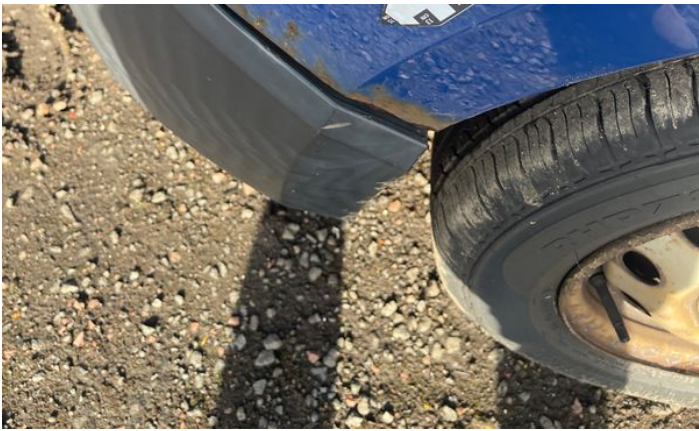
11: Wing nsf  
Rusted  
Over 5mm
